**SITE INVESTIGATION
NEWPORT BANNING RANCH
ORANGE COUNTY, CALIFORNIA**

West Newport Oil Company
1080 W. 17th Street
Costa Mesa, California 92627

GeoSyntec Consultants
2100 Main Street, Suite 150
Huntington Beach, California 92648
(714) 969-0800

November 2001

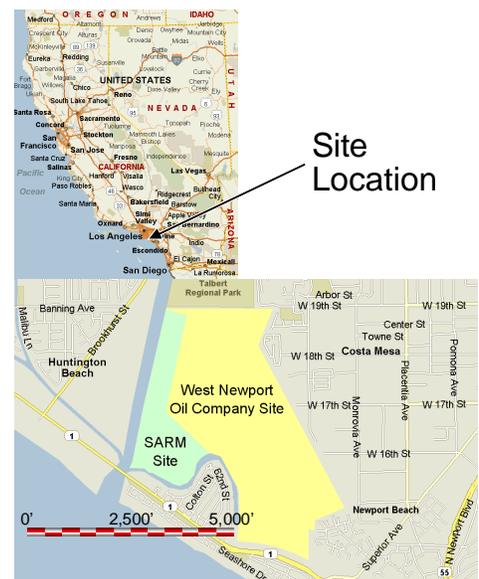
Figure 1-1: Site Map

The NBR site covers approximately 400 acres and is located east of the mouth of the Santa Ana River near the Huntington Beach – Newport Beach city boundary in Orange County, California (Figure 1-1). The NBR is currently operated as a crude oil and natural gas production facility by the WNOC. Oil and natural gas production operations are conducted at the NBR as certain areas are being abandoned.

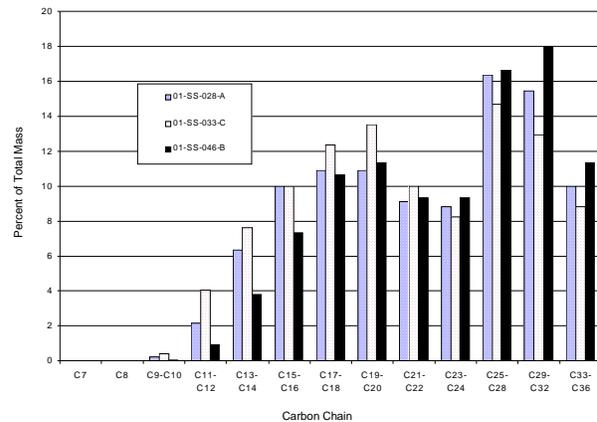
Figure 3-1: PEC #01 Maintenance Shop/Warehouse Hydrocarbon Chain Speciation

2. No samples indicated constituents above State Total Threshold Limit Concentrations (TTLC).
3. The carbon chain composition of the petroleum impacts was evaluated in PEC #01, PEC #02, PEC #08, and PEC #20. With the exception of one sample from PEC #02, the carbon chain signatures were similar, indicative of a weathered crude oil. An example of this crude oil signature is presented in Figure 3-1. Each sample is weighted toward the long-chain hydrocarbons (> C12). This signature is also evident in the crude oil free-product sample collected from Groundwater Well 02-GW-002 (Figure 3-2). The one exception was a sample from PEC #02 (02-SS-046B), which indicated

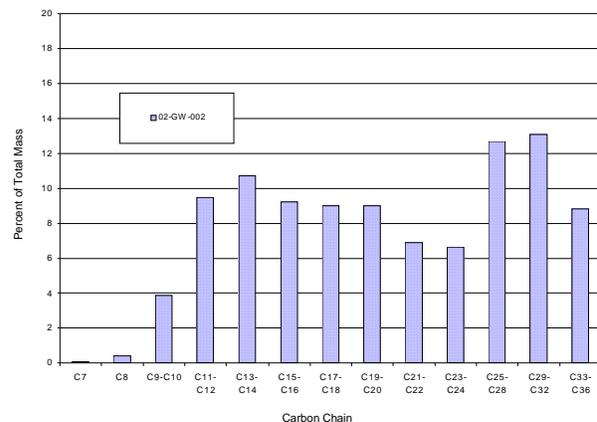
Figure 3-2: PEC #02 Main Site Tank Farm, Free Product Sample Hydrocarbon Chain Speciation

As indicated previously, temporary Groundwater Well 02-GW-002, installed at PEC #02, was found to be impacted by crude oil as a free product. A sample of the free product was collected for total hydrocarbon and carbon chain analyses. Results of the crude oil sample were used for comparison to hydrocarbon results from soil samples. As discussed in Section 3, the free product sample from Groundwater Well 02-GW-002 provides a signature of the weathered crude oil (Figure 3-2). Hydrocarbon analyses from sample 02-GW-002 indicate an absence of light weight hydrocarbon (less than C9) and a distribution (7 to 13 percent) of the total hydrocarbon mass detected amongst each of the hydrocarbon chains. A comparison of crude oil and total carbon chain results indicates that approximately 50 percent of the hydrocarbon mass is greater than C36, indicative of highly weathered product. As expected, PAH and VOC were detected in the crude oil sample above state MCLs. These impacts were not present in samples collected from other wells within PEC #02, indicating that the impacts are localized around 02-GW-002. However, groundwater samples collected from other wells did detect dissolved phase hydrocarbons at concentrations up to 26 ppm (TPH, crude oil standard) in 02-GW-003.

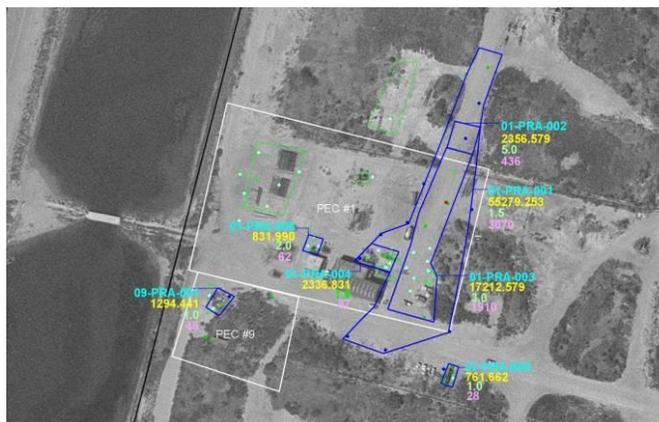
Soil and groundwater quality was evaluated in PEC #01, both by visual observation and chemical laboratory testing. Results indicate that approximately 5,600 cubic yards of soil (estimated gross volume) are impacted. In addition, groundwater was found to be impacted by VOCs, however, no constituents exceeded State MCLs. Results from the laboratory and visual observations were combined to evaluate the amount of soil impacted within PEC #01. The data were divided into 6 separate subareas (denoted potential remediation areas [PRAs] in Table 4-1, 01-PRA-001 through 01-PRA-006). These areas are highlighted on Figure 5-1, along with the anticipated extents of impact in each subarea (both vertically and horizontally), and potential sources.

# Wells	# Pits/Borings	# Samples	# Tests
3	55	31	108
Estimated Volume of Impacted Soil – 5,600 cy

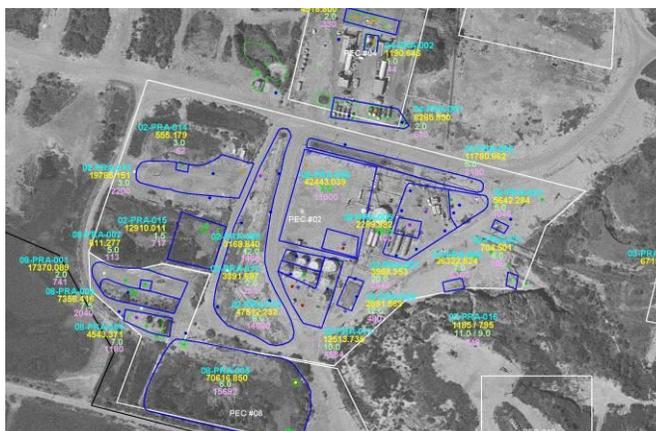
Soil and groundwater quality was evaluated in PEC #02, both by visual observation and chemical laboratory testing. Results indicate that approximately 44,600 cubic yards of soil (gross) are impacted. In addition, groundwater was found to be impacted by free-product over an area of approximately 0.75 acre. Results from the laboratory and visual observations were combined to evaluate the amount of soil impacted within PEC #02. The data were divided into 15 separate subareas (02-PRA-001 through 02-PRA-015 in Table 4-1). These areas are highlighted on Figure 5-2, along with the anticipated extents of impact in each subarea (both vertically and horizontally), and potential sources. The recent data collection effort was augmented by historical testing in this area that took place in 1996. Both data sets are discussed in the following sections.

# Wells	# Pits/Borings	# Samples	# Tests
5	67	42	133
Estimated Volume of Impacted Soil – 44,600 cy			
Estimated Area of Impacted Groundwater – 0.75 ac

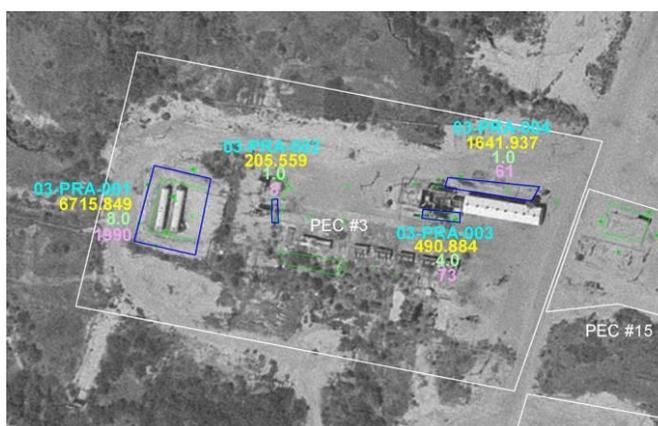
Soil quality was evaluated in PEC #03, both by visual observation and chemical laboratory testing. Results indicate that approximately 2,100 cubic yards of soil (estimated gross volume) are impacted. Results from the laboratory and visual observations were combined to evaluate the amount of soil impacted within PEC #03. The data were divided into 4 separate subareas (03-PRA-001 through 03-PRA-004 in Table 4-1). These areas are highlighted on Figure 5-3, along with the anticipated extents of impact in each subarea (both vertically and horizontally), and potential sources.

# Pits/Borings	# Samples	# Tests
21	7	25
Estimated Volume of Impacted Soil – 2,100 cy

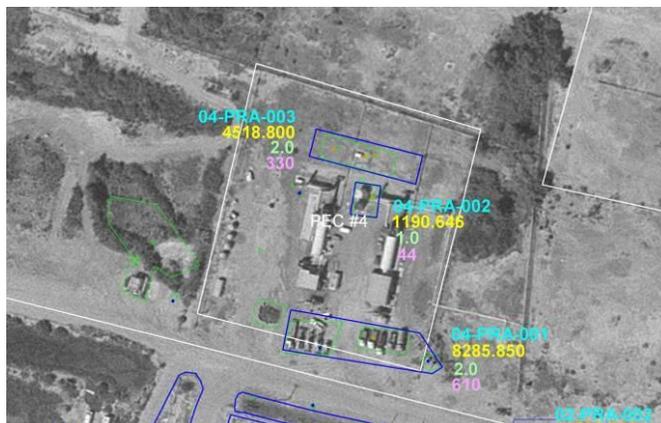
Soil quality was evaluated in PEC #04, both by visual observation and chemical laboratory testing. Results indicate that approximately 1,000 cubic yards of soil (estimated gross volume) are impacted. Results from the laboratory and visual observations were combined to evaluate the amount of soil impacted within PEC #04. The data were divided into 3 separate subareas (04-PRA-001 through 04-PRA-003 in Table 4-1). These areas are highlighted on Figure 5-4, along with the anticipated extents of impact in each subarea (both vertically and horizontally), and potential sources.

# Pits/Borings	# Samples	# Tests
13	10	27
Estimated Volume of Impacted Soil – 1,000 cy

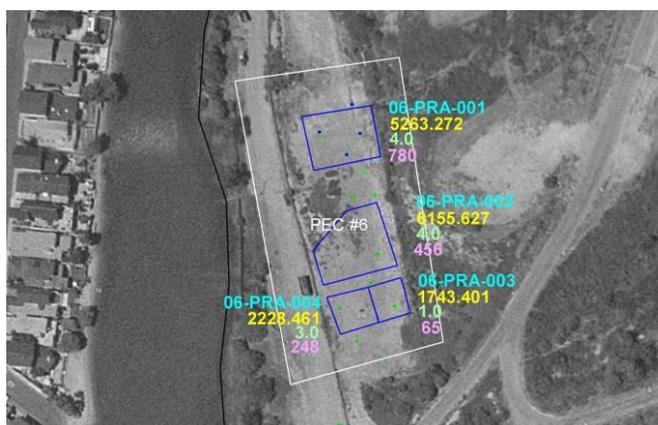
Soil and groundwater quality was evaluated in PEC #06, both by visual observation and chemical laboratory testing. Results indicate that approximately 1,500 cubic yards of soil (estimated gross volume) are impacted. No groundwater impacts were observed or indicated by laboratory results. Results from the laboratory and visual observations were combined to evaluate the amount of soil impacted within PEC #06. The data were divided into 4 separate subareas (06-PRA-001 through 06-PRA-004 in Table 4-1). These areas are highlighted on Figure 5-5, along with the anticipated extents of impact in each subarea (both vertically and horizontally), and potential sources.

# Wells	# Pits/Borings	# Samples	# Tests
1	13	10	29
Estimated Volume of Impacted Soil – 1,500 cy

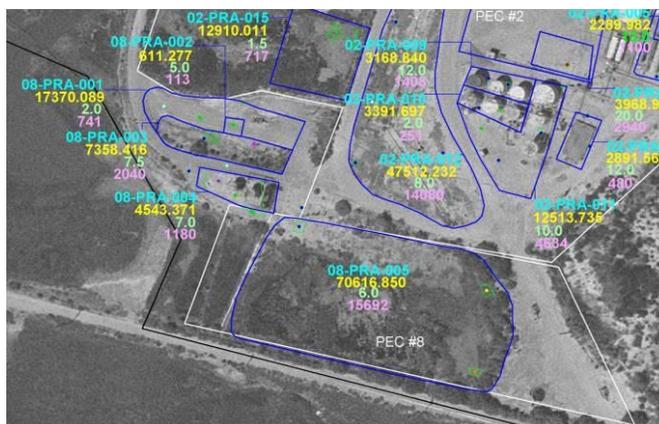
Soil and groundwater quality was evaluated in PEC #08, both by visual observation and chemical laboratory testing. Results indicate that approximately 19,800 cubic yards of soil (gross) are impacted. No groundwater impacts were observed or indicated by laboratory results. Results from the laboratory and visual observations were combined to evaluate the amount of soil impacted within PEC #08. The data were divided into 5 separate subareas (08-PRA-001 through 08-PRA-005 in Table 4-1). These areas are highlighted on Figure 5-2, along with the anticipated extents of impact in each subarea (both vertically and horizontally), and potential sources.

# Wells	# Pits/Borings	# Samples	# Tests
1	15	10	38
Estimated Volume of Impacted Soil – 19,800 cy

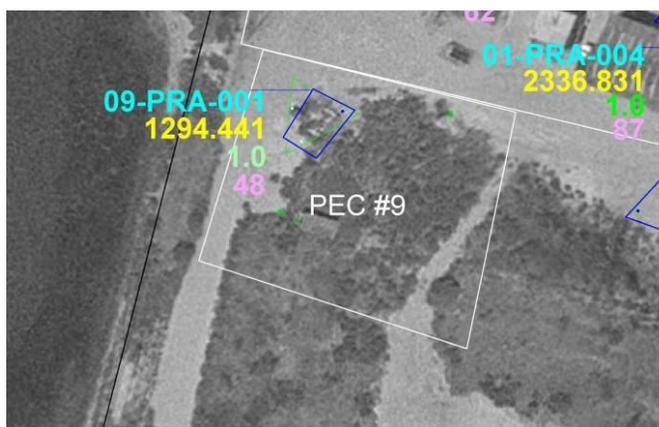
Soil quality was evaluated in PEC #09, both by visual observation and chemical laboratory testing. Results indicate that approximately 50 cubic yards of soil (estimated gross volume) are impacted. Results from the laboratory and visual observations were combined to evaluate the amount of soil impacted within PEC #09. Based on the data, a single subarea was designated as a PRA for this PEC (09-PRA-001 in Table 4-1). This area is highlighted on Figure 5-1, along with the anticipated extents of impact in the subarea (both vertically and horizontally), and the potential source.

# Pits/Borings	# Samples	# Tests
4	2	8
Estimated Volume of Impacted Soil – 50 cy

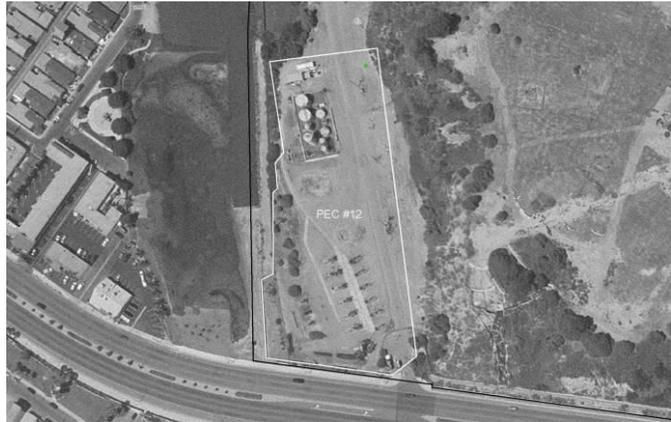
Soil quality at the City of Newport Beach tank farm was evaluated with the excavation of 3 test pits. Test pits were excavated on 7 June 2001. A total of 3 soil samples were collected for laboratory analysis at PEC #12. Appendix A includes site feature photographs and the approximate location where samples were collected. Soil samples collected from PEC #12 were only tested for hydrocarbons. Results of hydrocarbon analyses are included on Table 5-2.

Results of laboratory hydrocarbon analyses have indicated total hydrocarbon concentrations less than 20 ppm. However, hydrocarbon impacted material was visually identified in a limited area.

This area appears to be more consistent with impacts noted in PEC #06, therefore this volume of material will likely be included in the remediation plan for PEC #06. The estimated volume of hydrocarbon impacted soils at PEC #12 is less than 2 cy and therefore was not noted in Table 4-1.

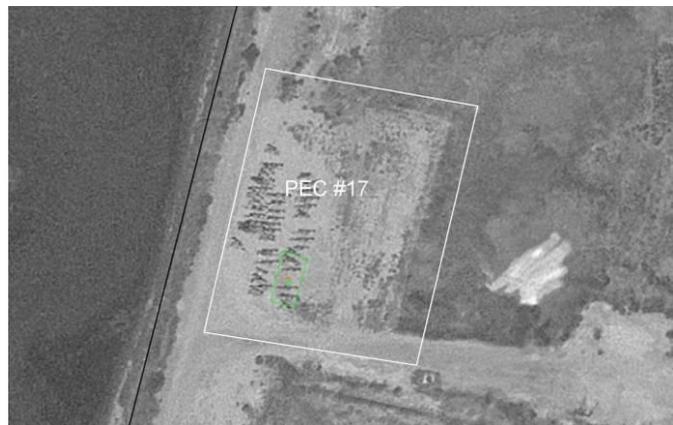
Soil quality was evaluated in PEC #17, both by visual observation and chemical laboratory testing. Results from the laboratory and visual observations were combined to evaluate the amount of soil impacted within PEC #17. The data show no significant impacts at this PEC.

Soil quality at PEC #17 was evaluated with the excavation of 1 hand auger boring. The hand auger boring was excavated on 11 May 2001. One soil sample was collected for laboratory analysis at PEC #17. Appendix A includes site feature photographs and the approximate location where the sample was collected. The soil sample was tested for hydrocarbons only. Results of hydrocarbon analyses are included on Table 5-2. Laboratory total

hydrocarbon results were less than 200 ppm and visually impacted material was not observed. Based on the results, potentially impacted material requiring further investigation was not identified at PEC #17.

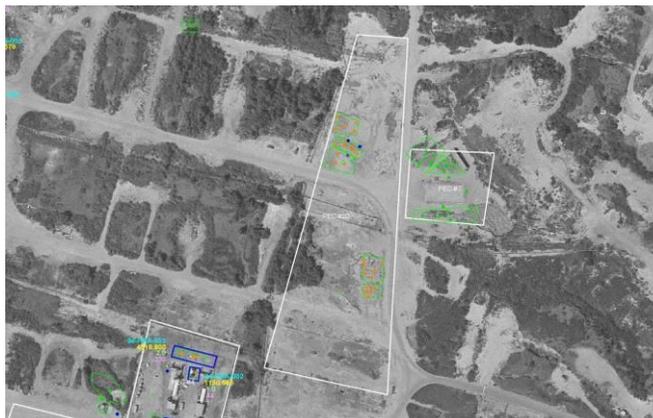
Soil quality at PEC #20 was evaluated with the excavation of 10 test pits and hand auger borings. Test pits and hand auger borings were excavated from 14 May to 15 May 2001. A total of 8 soil samples were collected for laboratory analysis at PEC #20. Appendix A includes site feature photographs and the approximate location where samples were collected. Soil samples were tested for a combination of hydrocarbons, metals, SVOCs, VOCs, PCBs and pesticides, and general minerals. Results of metal analyses from soil samples are included on Table 3-2. Results of hydrocarbon and organic analyses are included on Table 3-3. Results of general mineral analyses of soil samples are included on Table 3-4.

# Pits/Borings	# Samples	# Tests
4	1	23
Estimated Volume of Soil – 2,000 cy awaiting treatment

A carbon chain analysis was performed on one soil sample from PEC #20. The carbon chain analysis results indicate hydrocarbons in the range of C11 through C36, with a range of approximately 7 to 12 percent of the total hydrocarbon mass distributed amongst the various chain lengths similar to the weathered crude oil signature. Figure 3-6 presents the normalized hydrocarbon chain speciation results for the two soil samples collected at PEC #20. Laboratory results have shown concentrations of two PAHs, benzo(a)pyrene and dibenzo(a,h)anthracene above residential PRGs. Iron was also detected at a concentration above the residential PRG. These soils are awaiting treatment in the biotreatment cell. The extent of the impacted soil is approximately 2,000 cubic yards. In accordance with the criteria specified in Section 4, the estimated volume of impacted soils at PEC #20 is less than 2 cubic yards and therefore was not noted in Table 4-1.
