**FAULT TRENCHING INVESTIGATION,  
NEWPORT-BANNING PROPERTY,  
ORANGE COUNTY, CALIFORNIA**

November 25, 1997  
Project No. 978100-019

**Subject:** Final Report, Fault Trenching Investigation, Newport-Banning Property,  
Cities of Newport Beach and Costa Mesa and Unincorporated Orange  
County, California  
*(Leighton and Associates Project No. 1970011-001)*

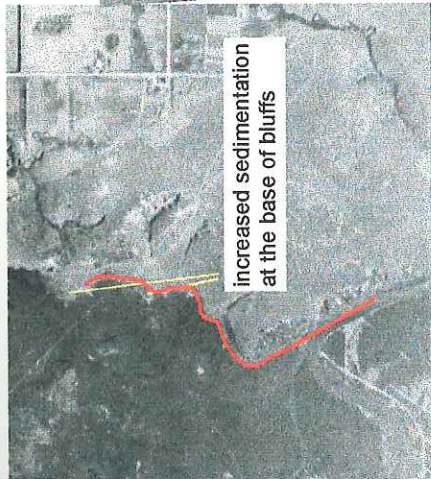
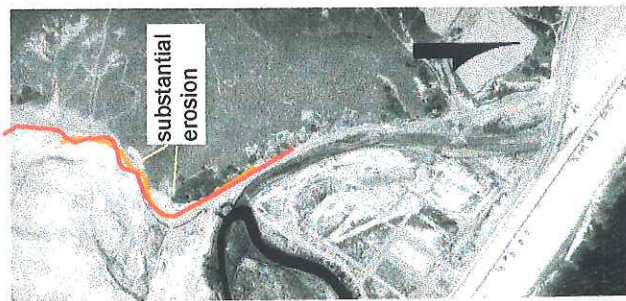
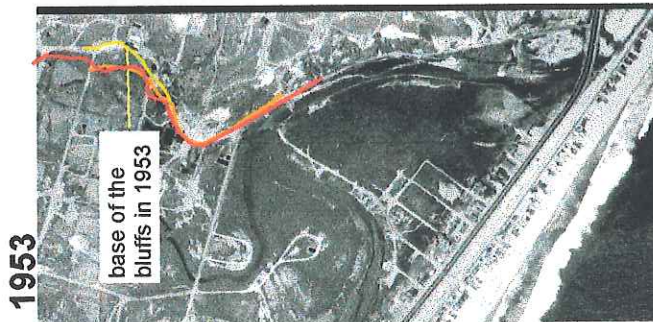
Figure 2

- Base of bluffs in 1927
- Water level against the base of the bluffs during the 1938 floods
